Cliff Reconnaissance Vehicle
« Cliffbot »
tests during the ÖWF Mars2013
simulation

Vienna 25-26/05/2013

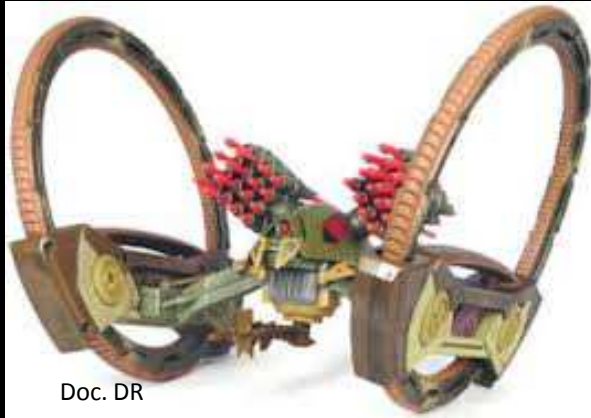
CRV3 1st tests – test 30

Down from 8.5 kg to 4 kg

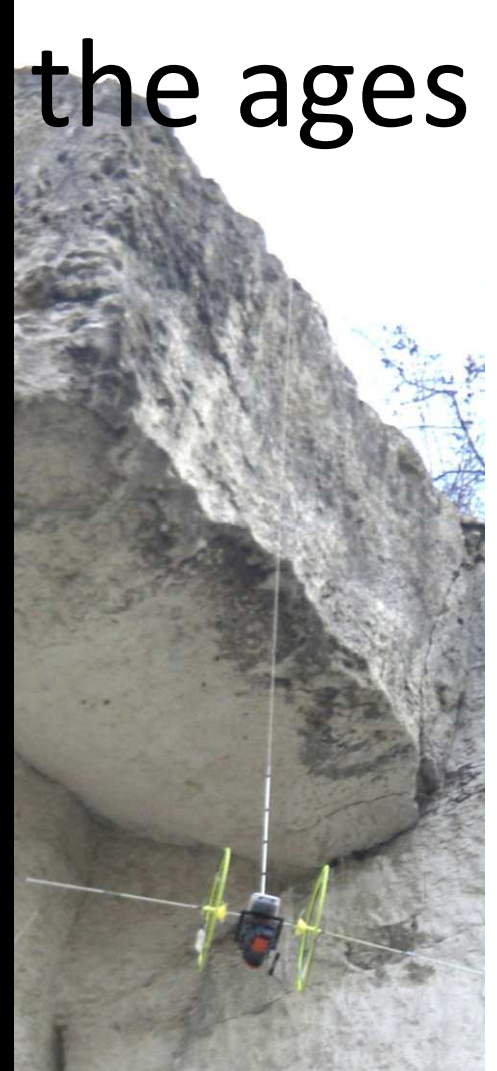
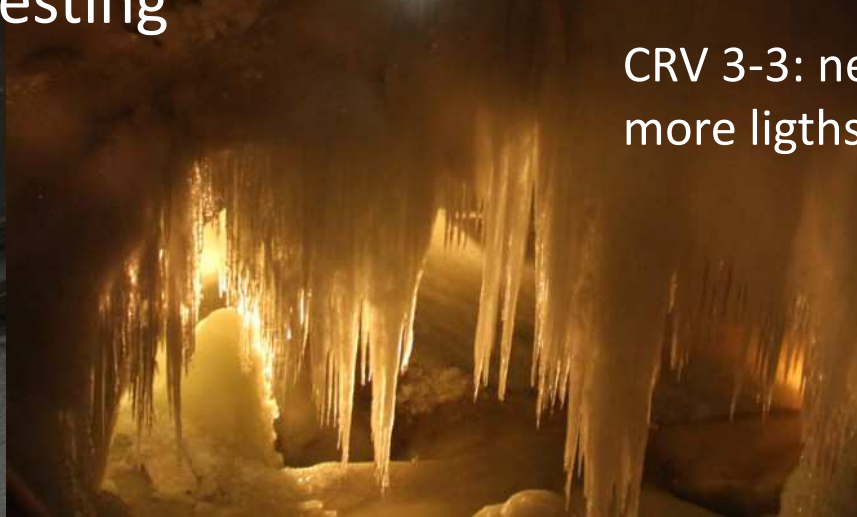
CRV 3-3: new wheels and hazcam; more lights

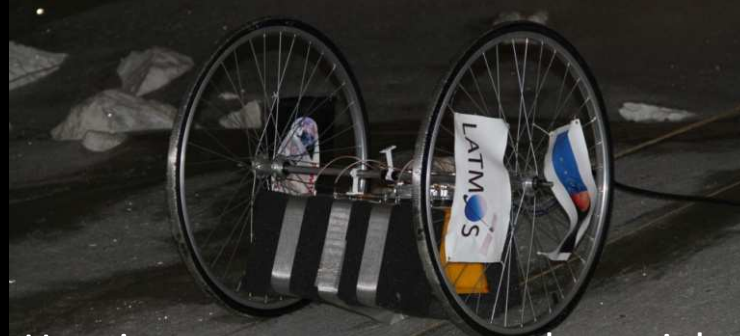
Heavier structure w.r. to radar weight

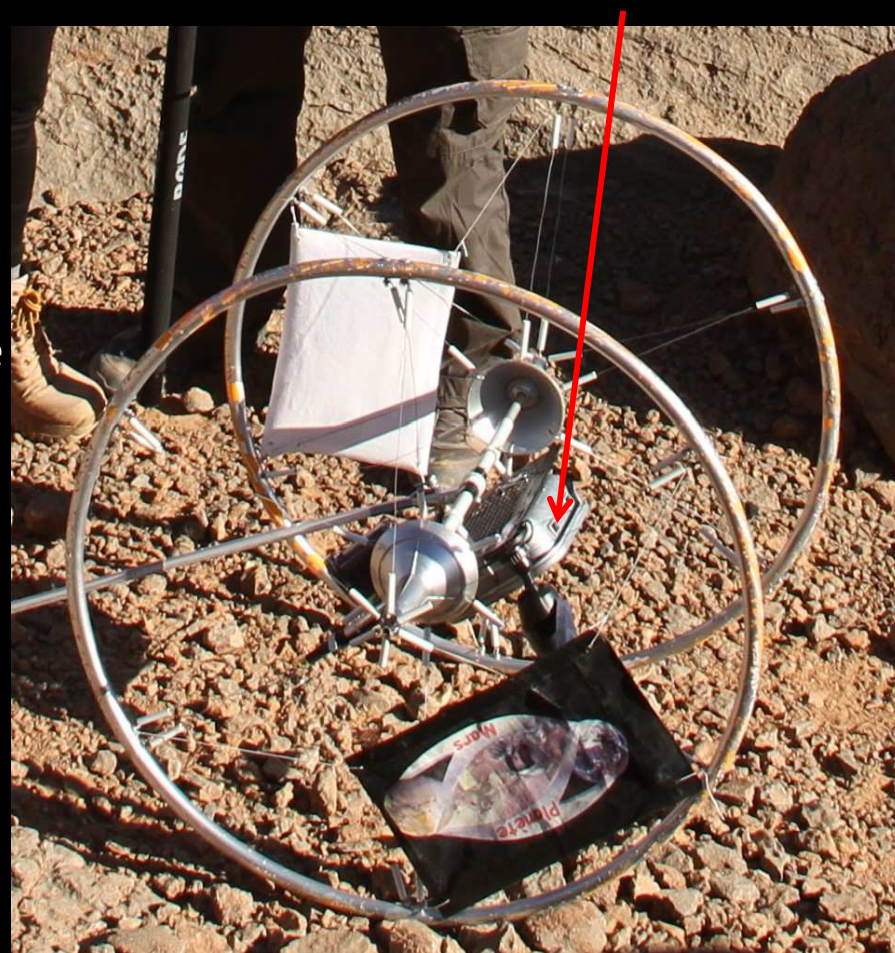
CRV 3-4 "Mars2013 configuration

Three flashlights which were on the 3-3 Dachstein configuration deleted: - 0,46 kg

Rear facing mirror for the Hazcam

Anti roll rods: rigid 50 cm fiber glass inner rod; flexible 50 cm plastic outer rod

Emitter video box located under the plate

New HD camera located above the plate: - 1,61 kg

- 2,07 kg
/Dachstein

Green laser
Red laser

Distance 22,5 cm

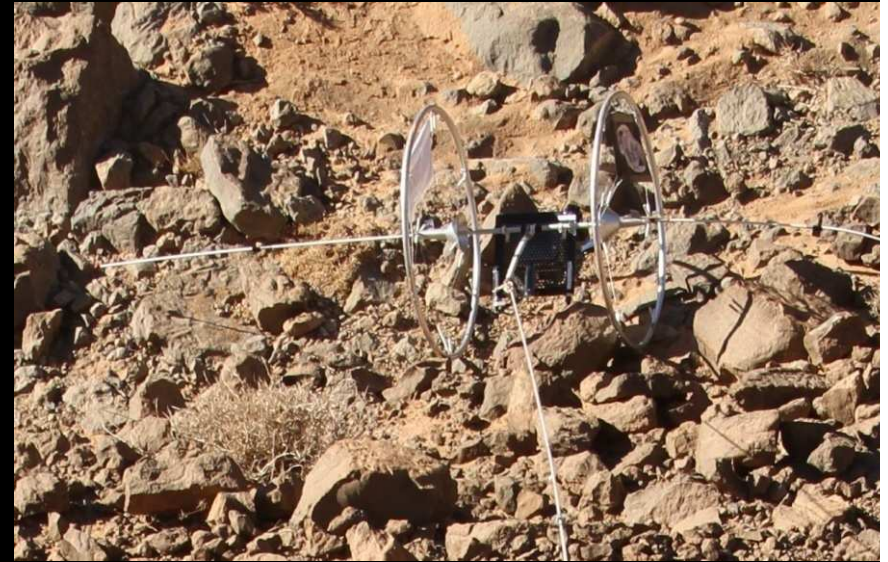
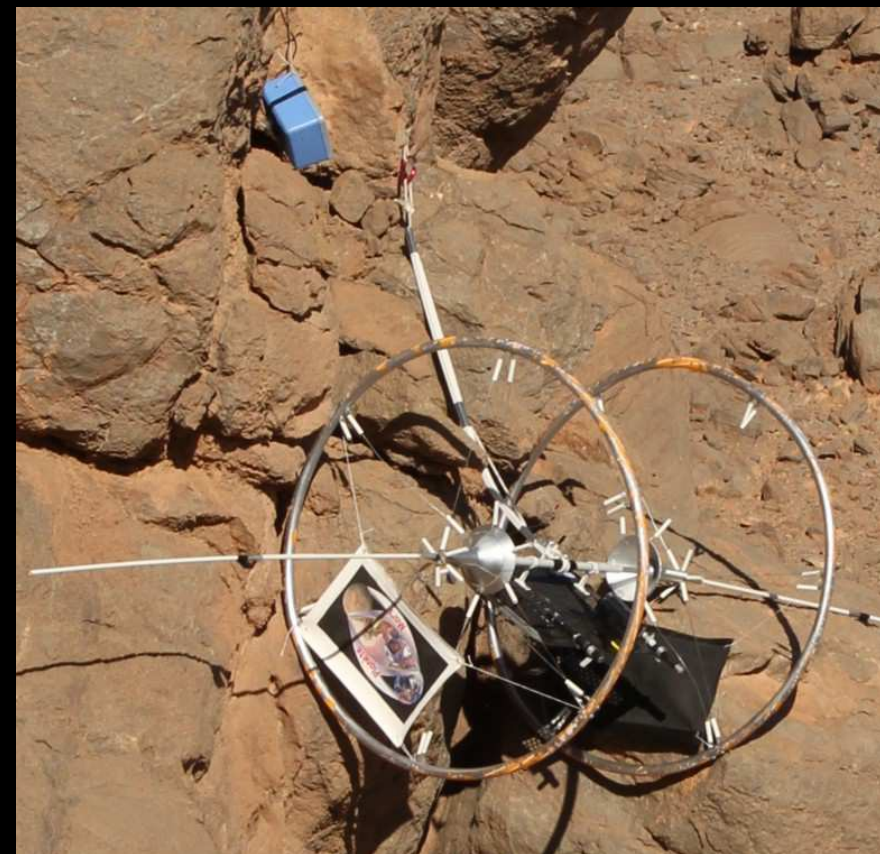
03 02 2013 test 93

The vehicle cannot be brought back because a rock protrudes between the spikes of the right wheel. This could be avoided by plain wheels or a spike fairing. Plain wheels were not selected to keep the capacity to disassemble the vehicle and store it in a suit case. The shallow rocky slope on which the problem appeared is not the primary objective for the vehicle operations

05 02 2013 test 96

Blockage on the way up with the yaw main rod stuck between two rocks

06 02 2013 test 97

Momentary blockage by the rope in a cliff crack

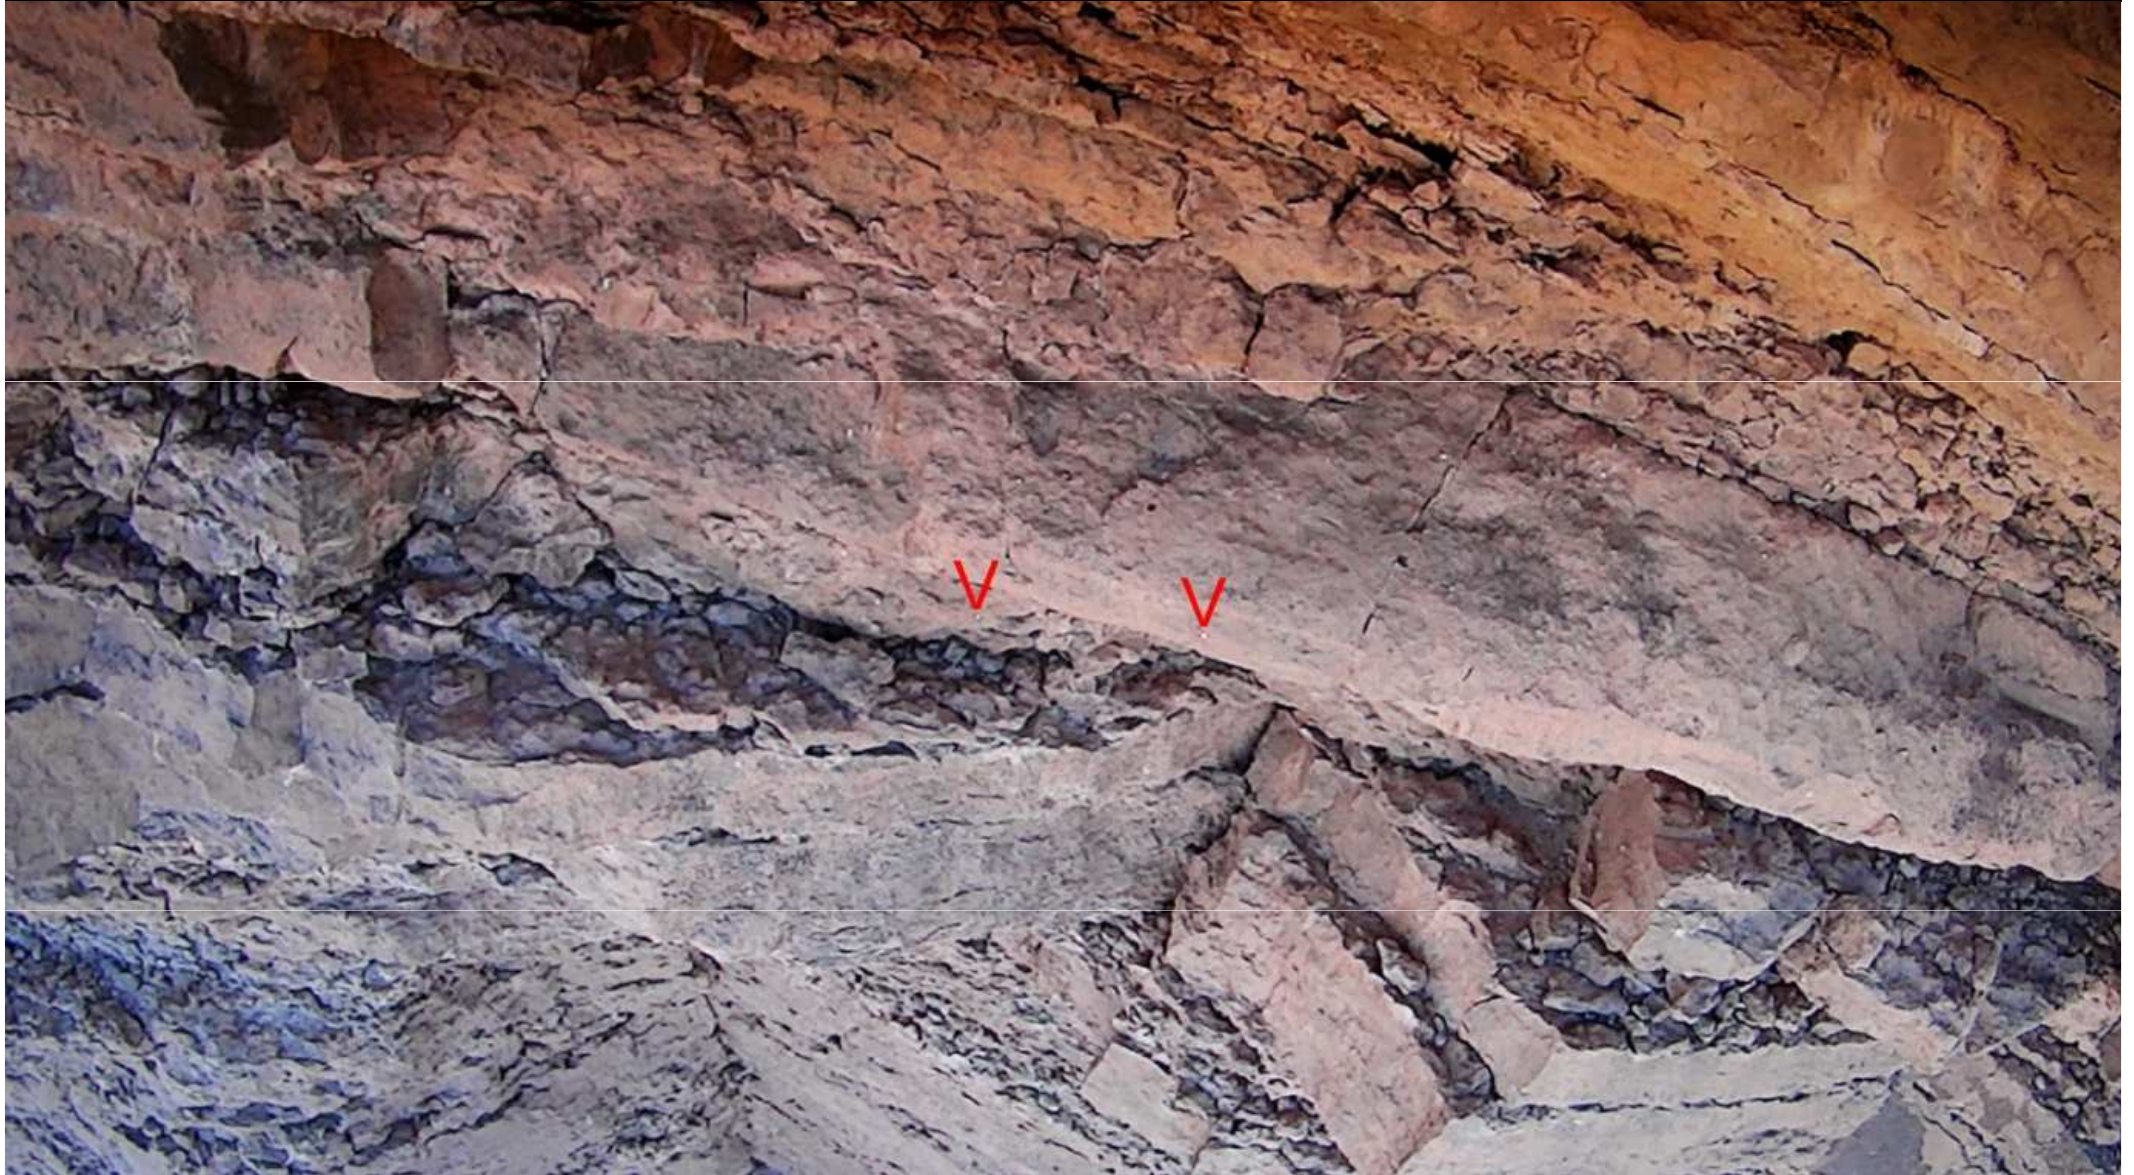
CRV 97 3mn 23s

70 cm overhang measured from the 2 lasers 22,5 cm distance
