Cliffbot CRV tests

Mars2013 simulation

Main results

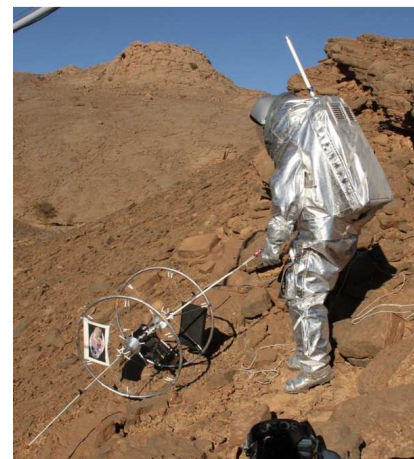
The CRV and an operator in the Aouda spacesuit

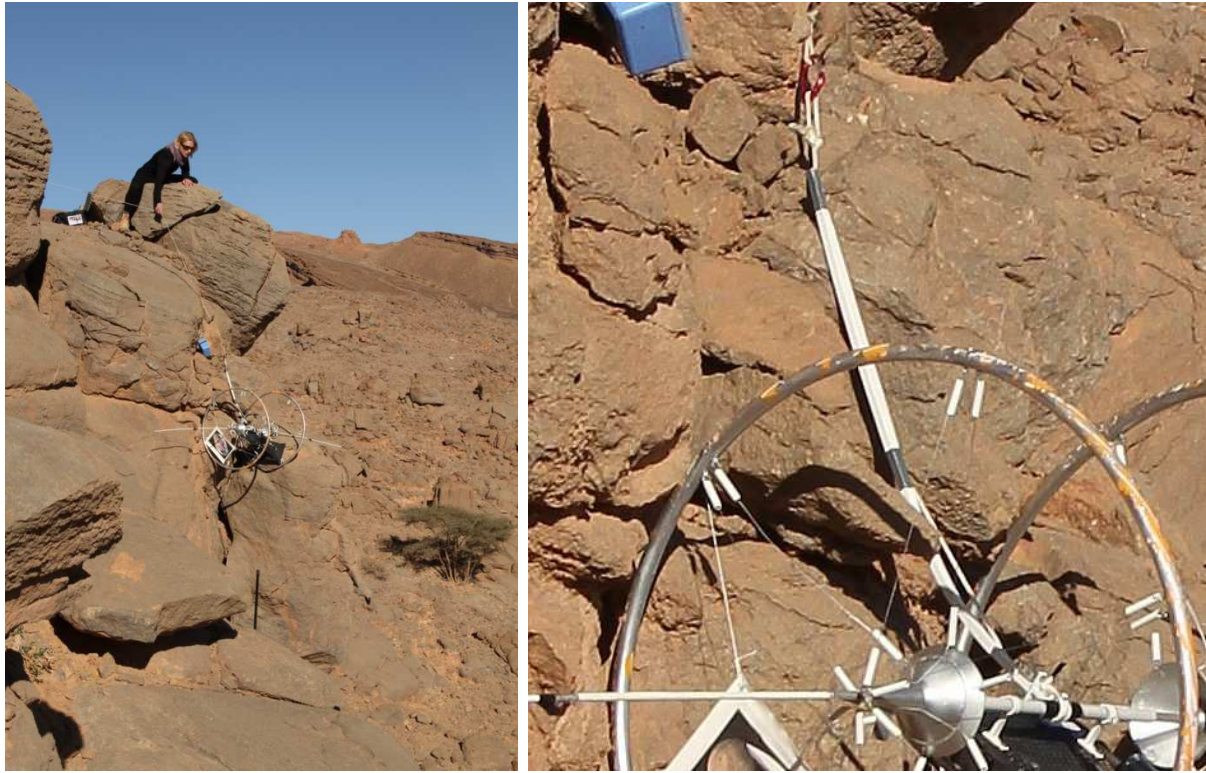
Vehicle blockage at the end of test 96: the anti yaw rod is engaged (and slightly bent) between two blocks. Under the vehicle (left photo) the black pole which will be used to push it upwards is visible.

During test 96 the vehicle was blocked on its way up a cliff. The rod linking the rope to the vehicle (also called anti yaw rod) engaged in a crack between two rocks which gave it a slight S shape. Releasing the rope was unable to let the vehicle go down under its own weight. The problem occurred 2 m from the top of a 18 m cliff. Fortunately a small plateau under the vehicle provided an access path from which the vehicle was pushed up by a 3 m rod. It is not known if pulling strongly the rope would have solved the problem.

It is interesting to note that the blockage during test 96 was not understandable from the Hazcam picture and also (later on during the analysis) from the Sciencecam picture. Understanding the blockage would have needed a lateral viewing camera looking at the right wheel. During the test 97, the blockage was understood by direct viewing and not by the Hazcam picture. Finally two 170° field of view cameras would be at minimum necessary. One solution tested in 2006 during the MDRS 43 simulation in Utah, was to install the Hazcam in a small pod roughly one meter above the vehicle on the rope and looking towards the vehicle. But the pod itself may be a blocking cause. In Utah it was only experimented on a smooth slope.

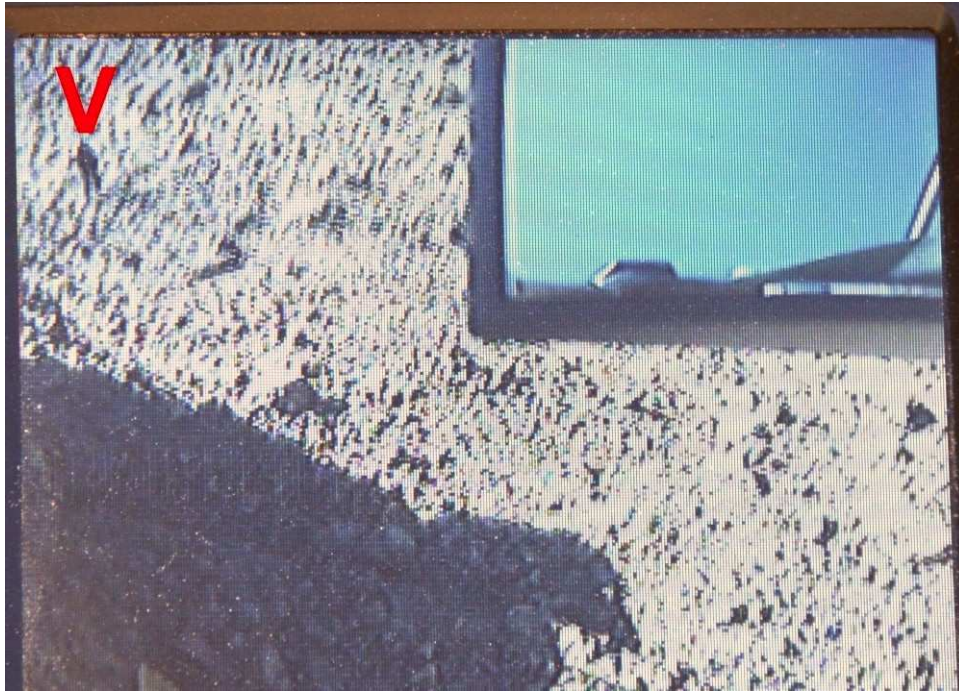
Picture from the Hazcam showing the debris slope with an observer in the upper left corner and the rear (upwards) facing mirror in the upper right corner

To improve the vehicle situation awareness by the operator the Hazcam which send real time pictures to the operator, was equipped with a rear facing mirror. For the Morocco campaign the Hazcam was oriented downwards. The orientation can be modified before a test. The rear facing mirror was thus looking upwards, trying to provide a view towards the upper part of the cliff. The mirror takes one fourth of the camera field of view. Probably it is not enough to have a clear view of the vehicle surroundings. Initially the idea was to equip the vehicle with two Hazcam looking up and down, but a two channels TV emitter was not found in time for the vehicle delivery to Innsbruck in December 2012. A solution where the two camera signals could be alternatively received uphill with only one video channel could be also interesting. The mirror was lost during tests 97 to 100. It was reported by the operator, during tests 97 to 100, that the picture seen uphill from the downward looking Hazcam was giving indications on the vehicle rotation under an overhanging while the vehicle was not visible from above, thus also, by the way, indicating that it was proceeding under such an overhanging.

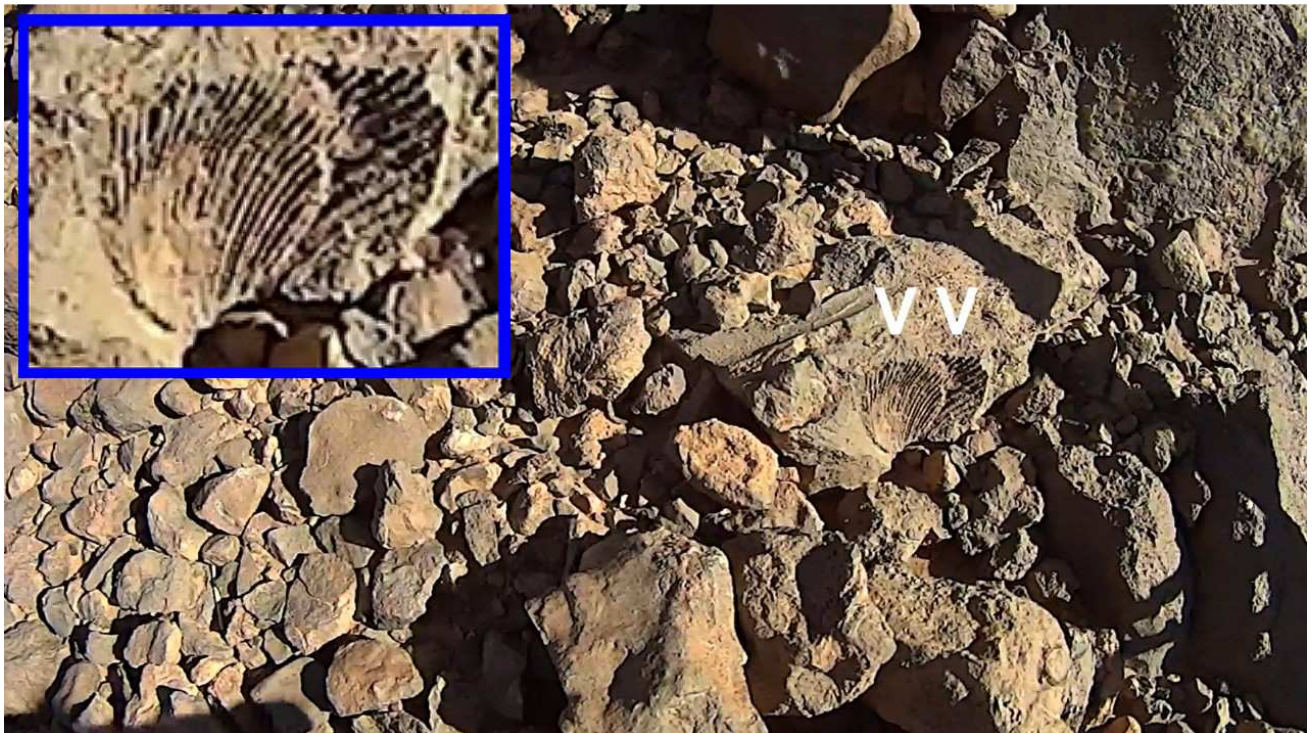
Test 94 time 24.42: two imbricated shell fossils.

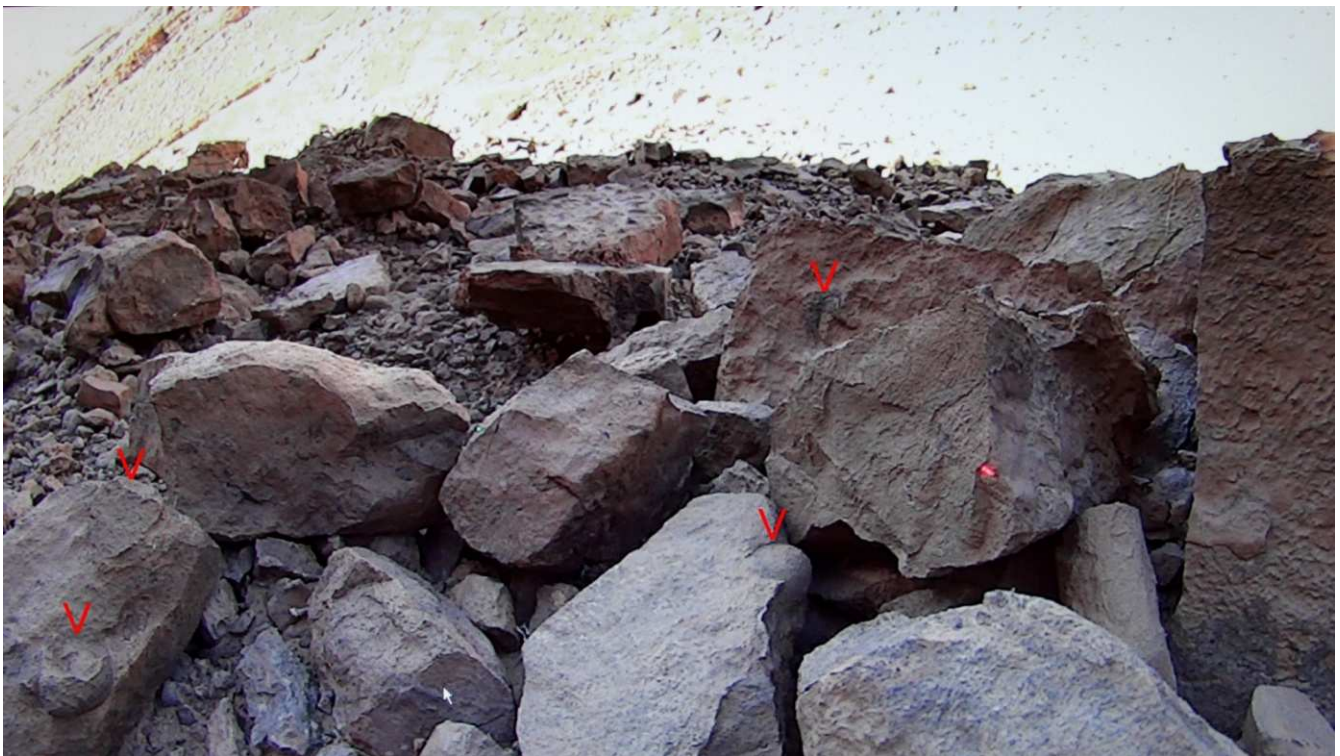
Test 97 time 9.33: possible fossils on the rocks in the debris slope.

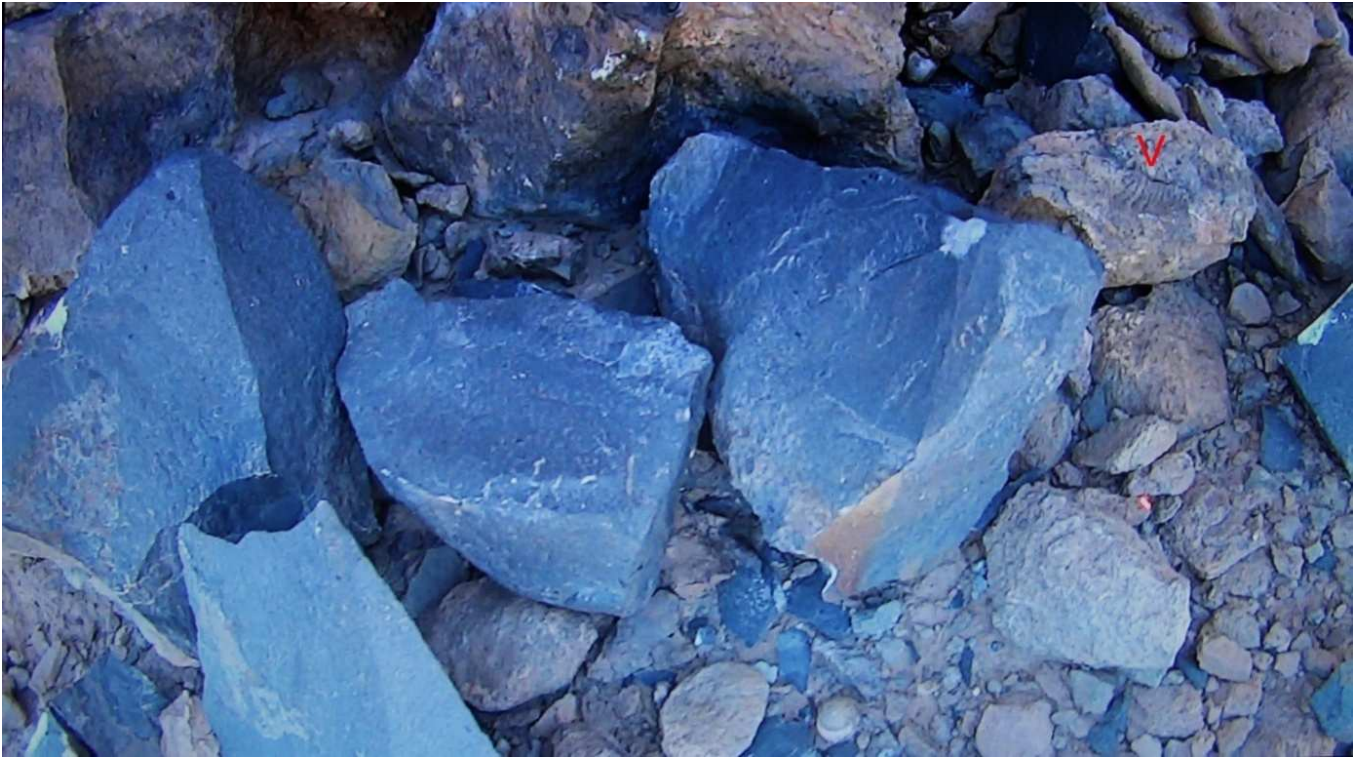
Test 98 time 2.48: blue rocks and a fossil in the upper right.

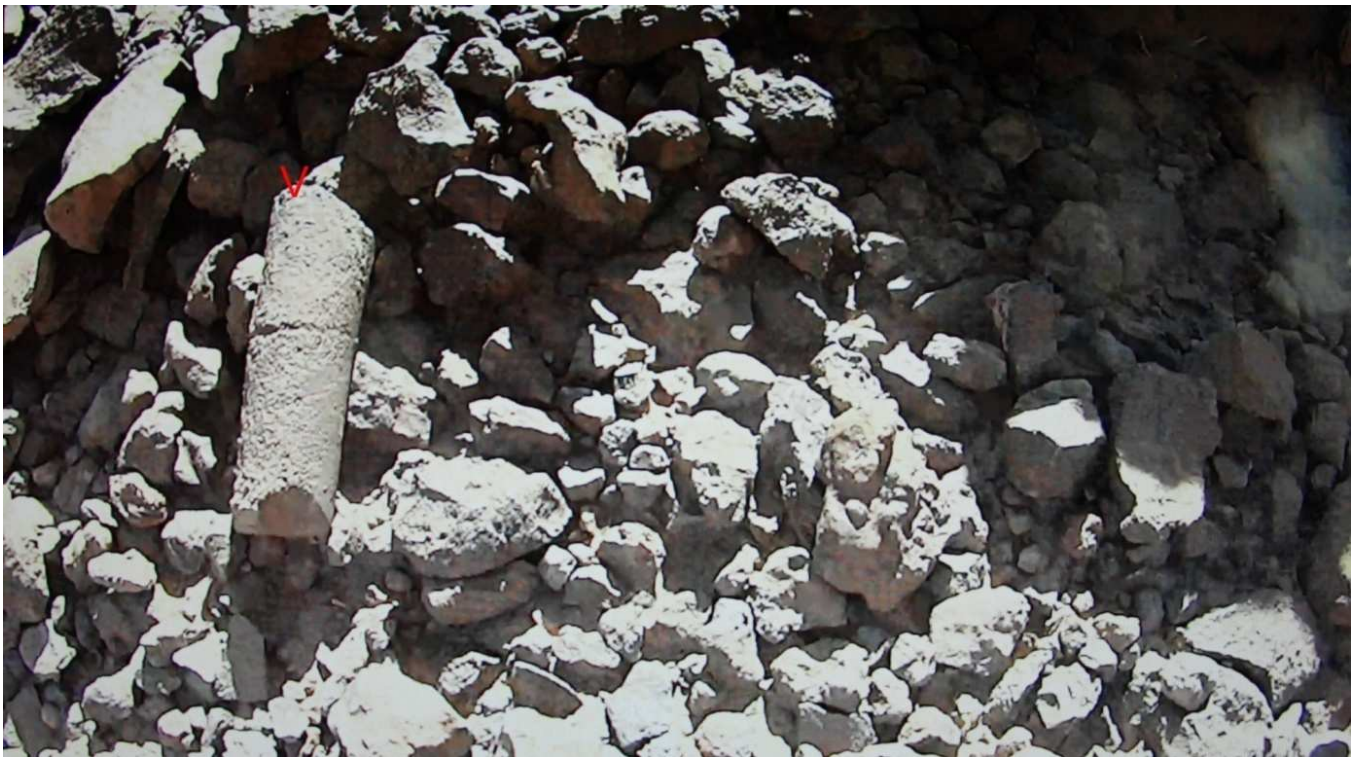
Test 98 time 5.01: cylindrical rock which may be a fossil. Many were found on the field.

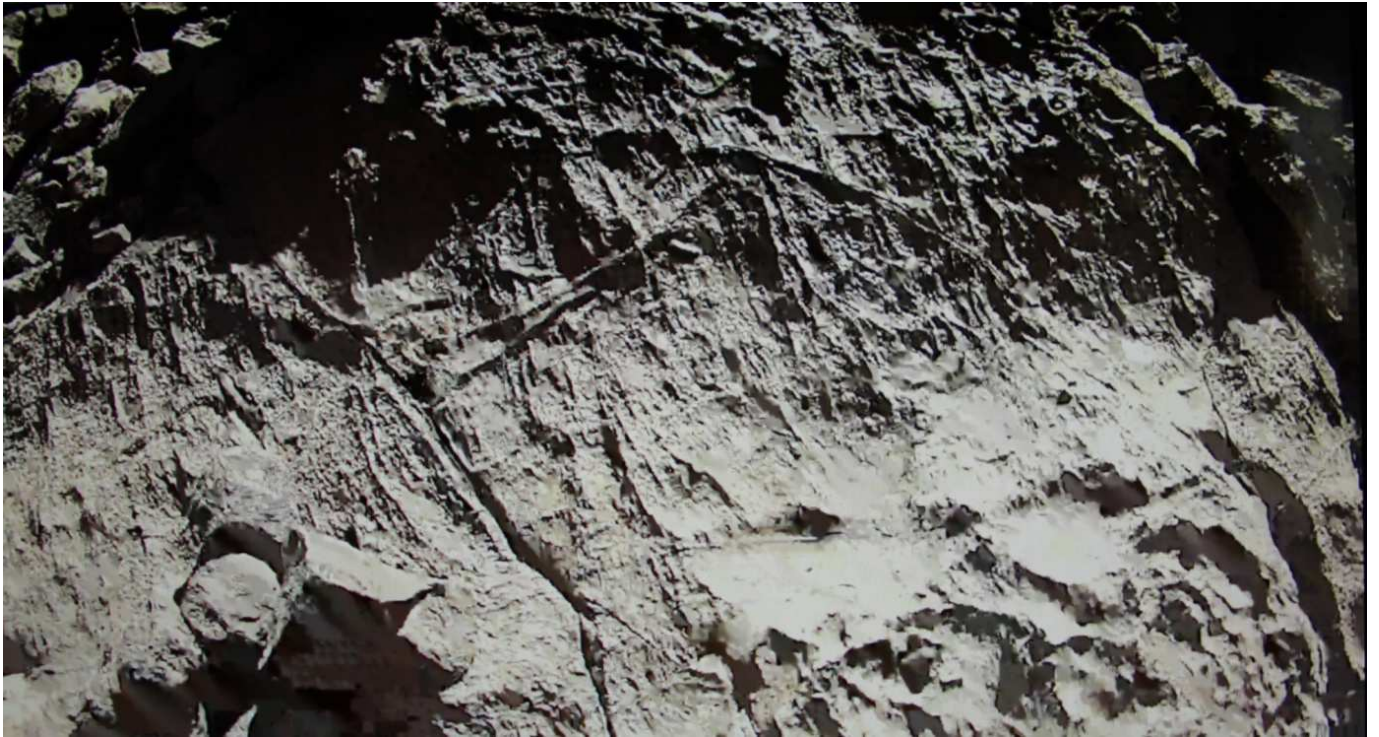
Test 98 time 5.11: striated rock.

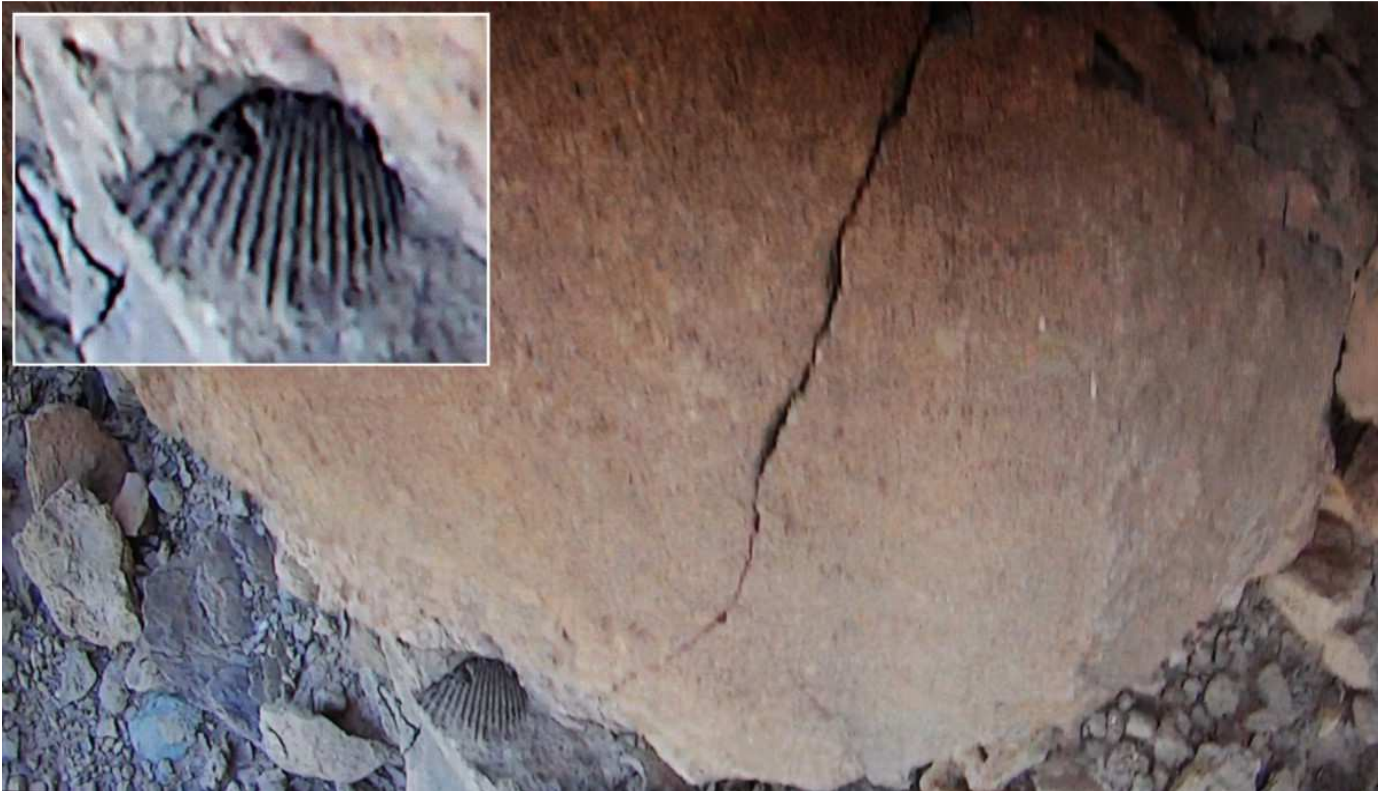
Test 98 time 7.58: nice fossil of a shell.

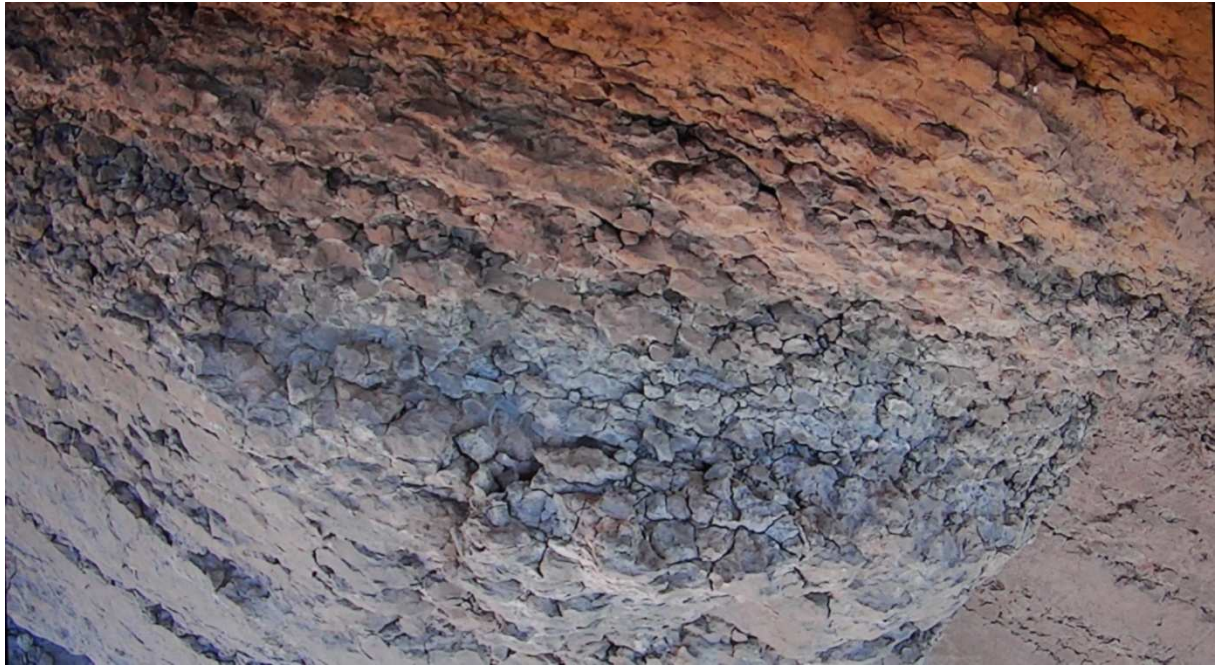
Test 100 time 0.36: grey blue area in the cliff.

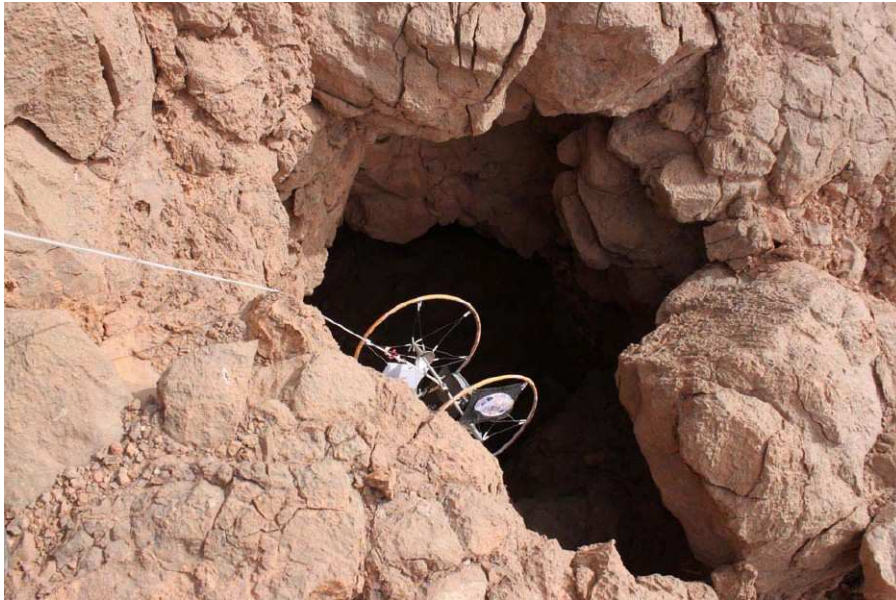
During test 102 the vehicle is sent in a cave (most probably the one visible in the previous photo; tbc). This is a nice demonstration of accessibility by the vehicle of an area which cannot be reached in a spacesuit.(Doc. OeWF).

The 18 th of February, the operating team discovered a cave with a sky opening in one of the Kess Kess mud volcanoes and sent the CRV exploring this cave. The anti roll rods were not fitted to the vehicle to decrease the vehicle width. The video taken on board is not yet available to determine if any interesting features were found.

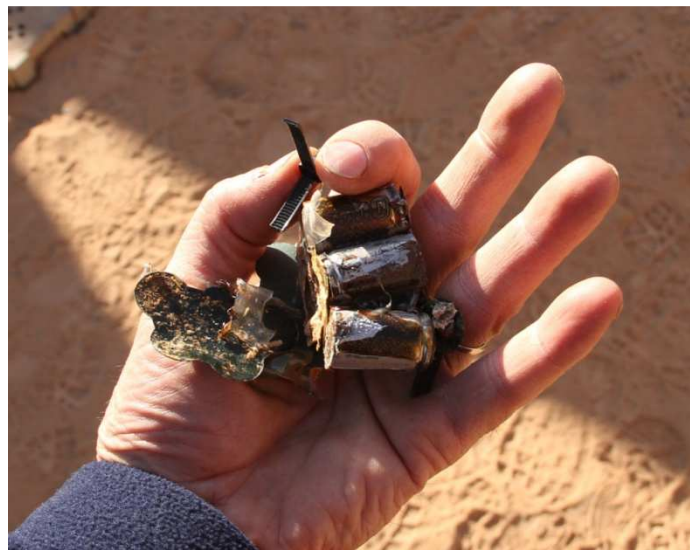
Overheated 6V battery one.

Concerning operations, a problem occurred the 6th of February during the batteries loading operations. The vehicle had to be ready at 11 am. The two 6V batteries charging is done in two steps: a long one under 6 V and a short one under 7.5 V. The battery n°1 was left under 7.5 V charging during breakfast and left too long (30 mn) leading to overheating. Fortunately a spare battery was available for this type of problems or others, and, at 9.41 am, the vehicle was ready with the new battery in place fully charged.
