# Cliffbot tests during Amadee-15 simulation

# Cliffbot objectives and tests objectives

# Cliffbot configuration

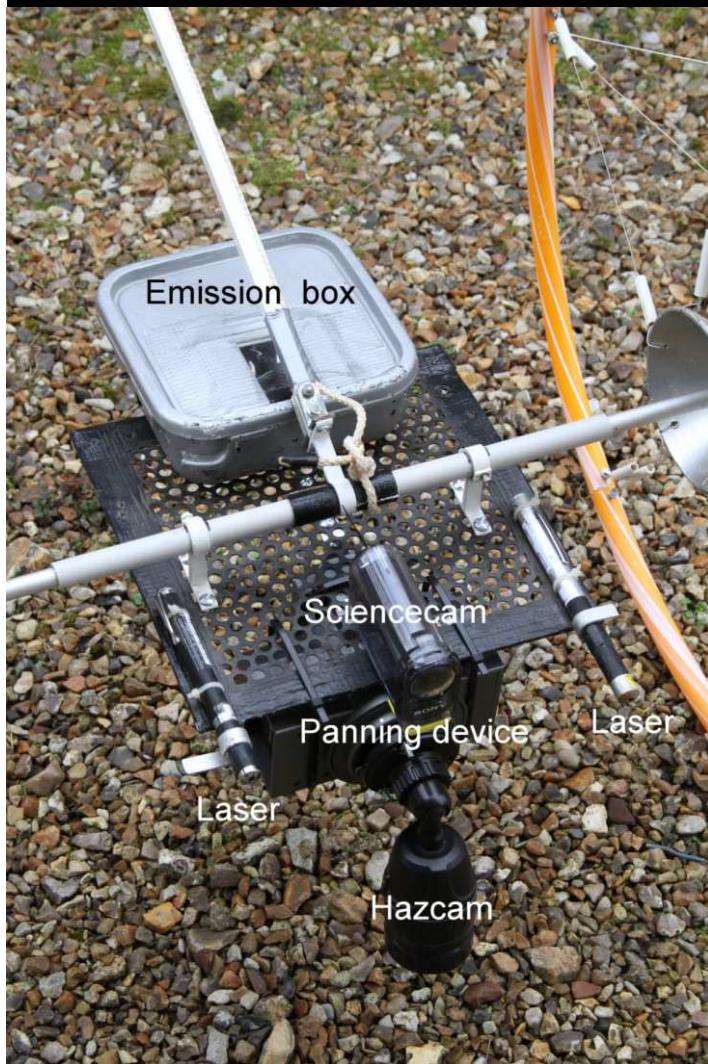
From CRV3-4 (Morrocco 2013) to CRV3-5 (Amadee-15):

- Hazcam field of view increased from  $75^\circ$  to  $105^\circ$
- Hazcam fixed on panning device (adjustable; used at  $\pm 170^\circ$ ) with angular speed  $8^\circ/\text{s}$
- Objective: improve vehicle situation awareness for the operator

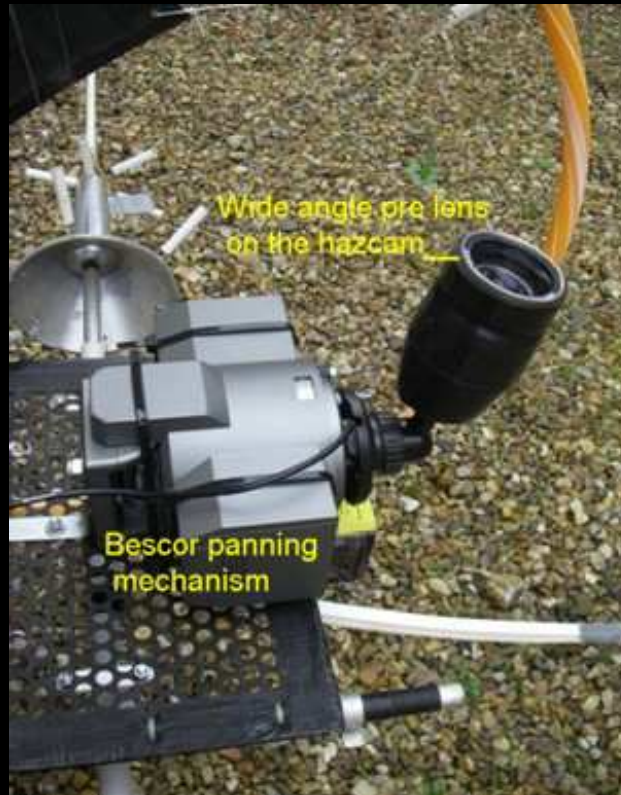
New equipments  
seen with the  
experiment plate  
upside down

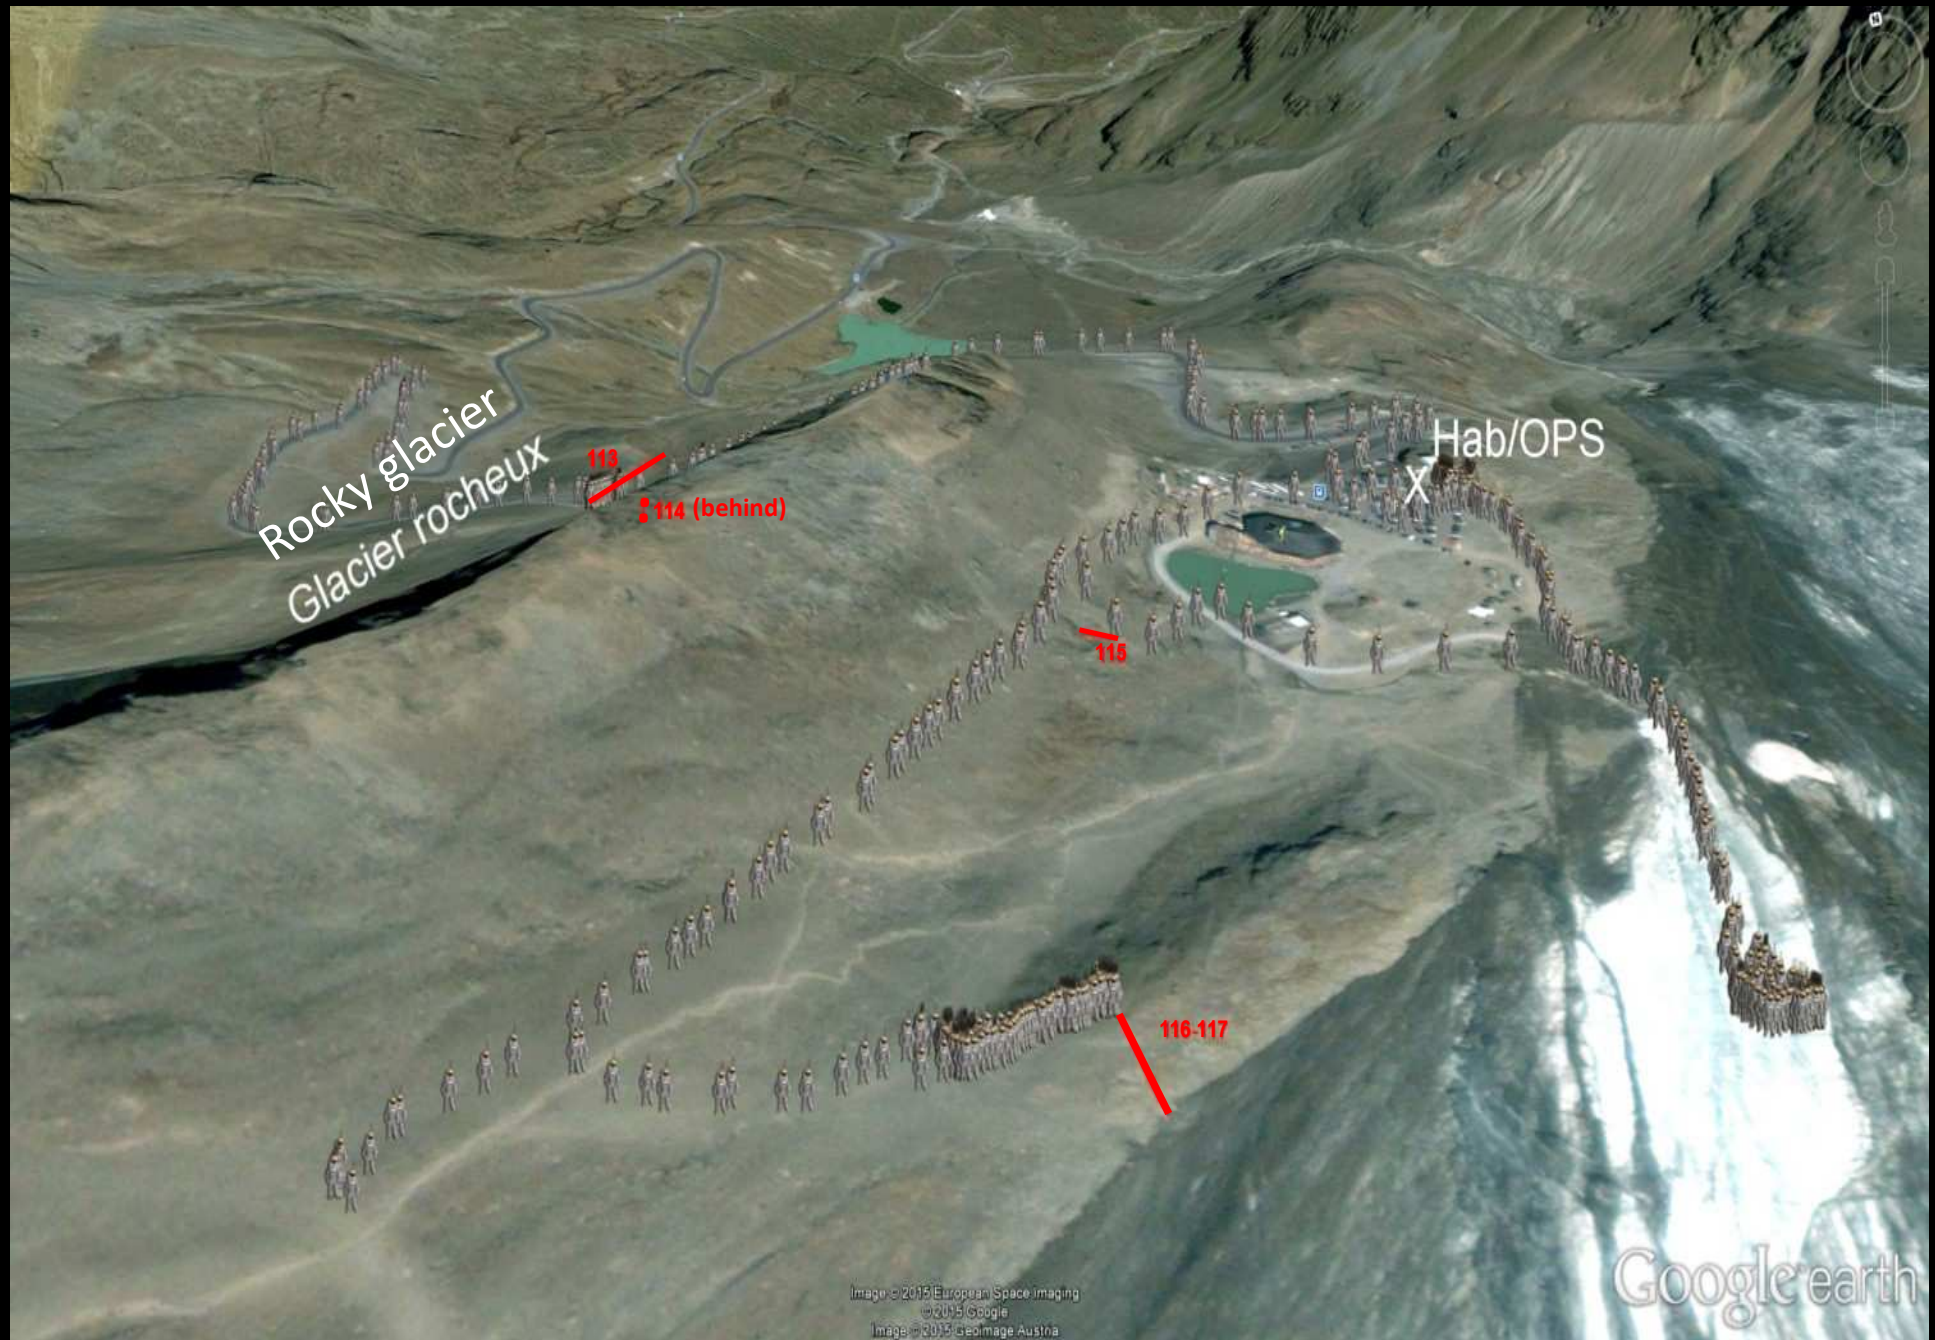
# Cliffbot tests locations

Test n°	Date	Location (+indication on map or photo if possible)	Vertical height m (evaluated)	Rope length m	Comments	Data acquired
113	1/8	Kaunertal glacier road. Starting point: skier bridge 500 m before end of road. Part of the rocky glacier under the road used as a ski path	30	87	Operations by PI. Debugging test on an easy slope. Length record for CRV tests. Good Hazcam video reception. Blockage (up and down) by a block protruding between the spokes or right wheel when coming back. Spokes to be tightened (lateral inclination of wheels). One spoke bolt lost. One flag attachment broken. The hazcam can enter in contact with rocks when in its down position on shallow slope. Its axis was oriented 30° from the panning axis (adjustment for low slope). Probably panning mechanism not to be used on rough terrain. 1h of operations including 2 trips to the vehicle location for close up photos	No Sciencecam operations exceptd 1 <sup>st</sup> meters (slope with no interest). Pictures of the vehicle including detailed views of the blocking rock. Pictures of the Hazcam monitor screen.

114	1/8	150 m above the previous test on a large snow patch, on the mountain side of the road	12	25	Operations by PI. One anti roll pin to be refixed. Hazcam enters in contact with snow when elevated ground between the wheels on shallow slope	Photos (no Science cam and no Hazcam operations)
115	5/8	Rock above the small lake along the path	8	7	Operations by PI. Demonstration test for the TV team RMC Découverte. 6 down and up runs. Test which can be used for lichen size measurements.	Sciencecam and Hazcam operationnal
116	8/8	Above the ice glacier			Operations by the analog astronauts. Cameras oriented towards the slope down side. Preceeding attempt the 7th aborted by rain (and also no hazcam video signal on the monitor). Video tests ok the 7th evening.	No sciencecam video available
117	12/8	Same location			Operations by the analog astronauts	No sciencecam video available

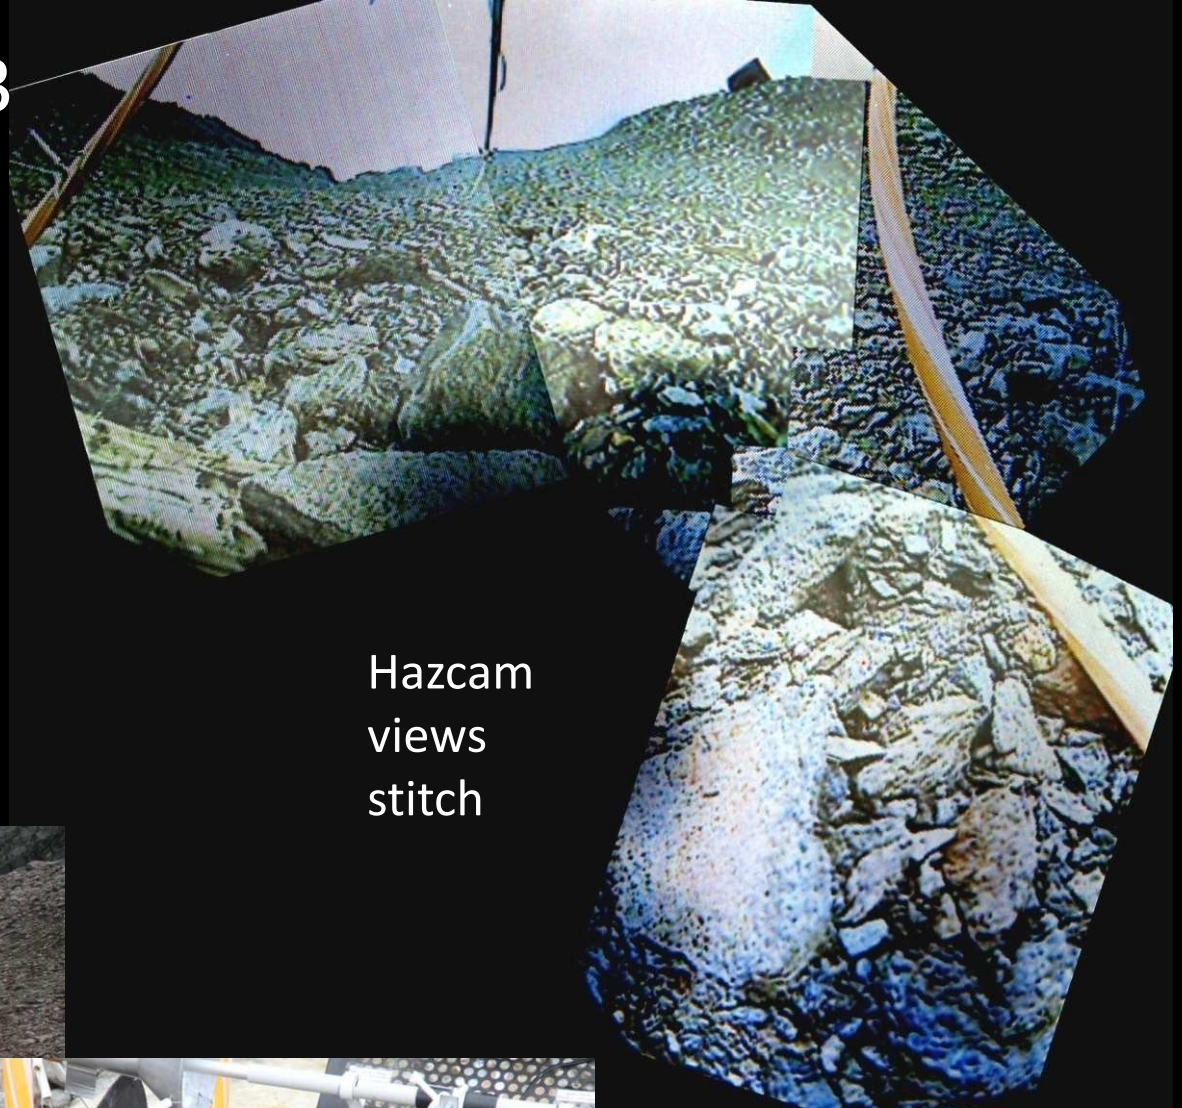
Test 113 87 m run  
location

Hazcam  
views  
stitch

Length record but on a shallow slope

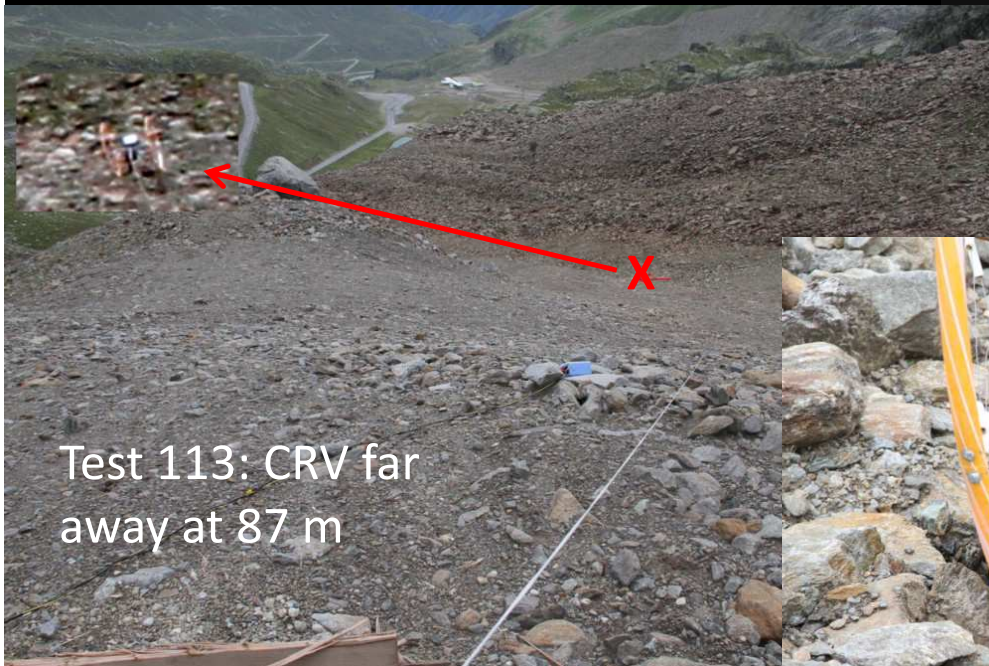
Test 113: CRV far  
away at 87 m

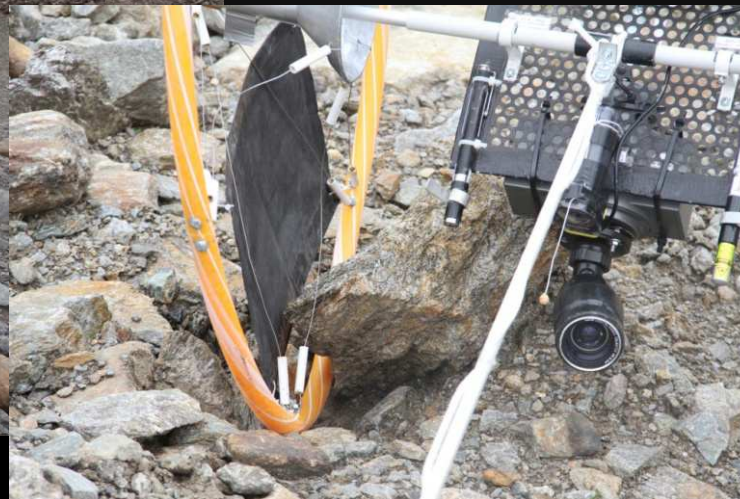
Rock between wheel and  
spikes blocking up and  
down motions but  
shallow slope – Seen also  
in Morocco – Could be  
solved by plain wheels

- **2<sup>nd</sup> test campaign in CRV3-5 configuration after MDRS 151**
- **Small number of tests during Amadee 15**
- **Some results:**
  - **Plain wheels would avoid some blockage (or wheels external covers)**
  - **The panning mechanism can move the hazcam camera lens in contact to obstacles mainly on shallow slopes. Relocation to be studied**
  - **Not enough data to assess if the panning system improves the vehicle situation awareness by the operator**
  - **Features measurement capabilities demonstrated on lichens**
  - **Need to improve analog astronauts training on the experiments ?**

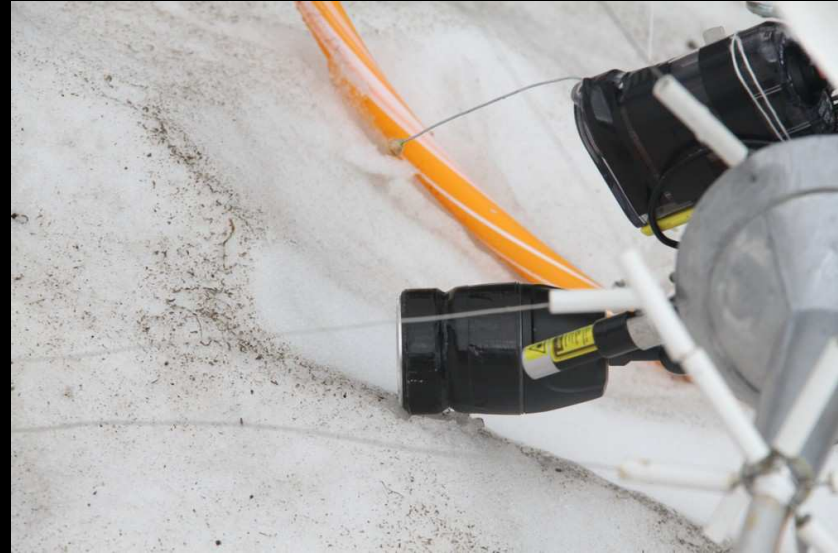
When elevated ground between wheels, the hazcam enters in contact with the ground in the panning motion – Depends on panning amplitude selected and on the slope (risk minimized on vertical slopes) - Could be improved by changing camera attachment point

Risk seen also on  
previous test on a  
shallow sope with  
rocks

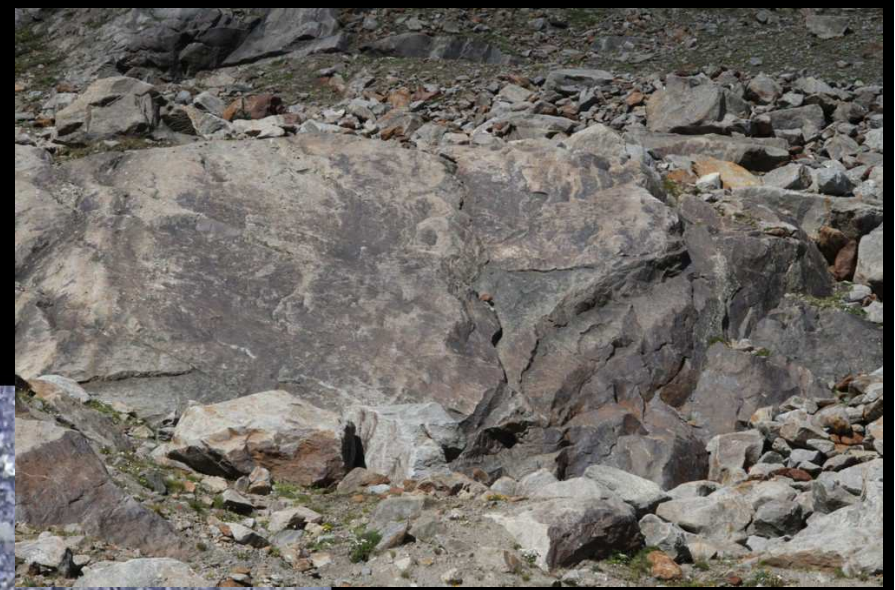
Test 115 rock  
slope location

Demonstration test for the RMC Découverte TV team  
By product: demonstration of the CRV capabilities in  
features measurement i.e. lichens diameter

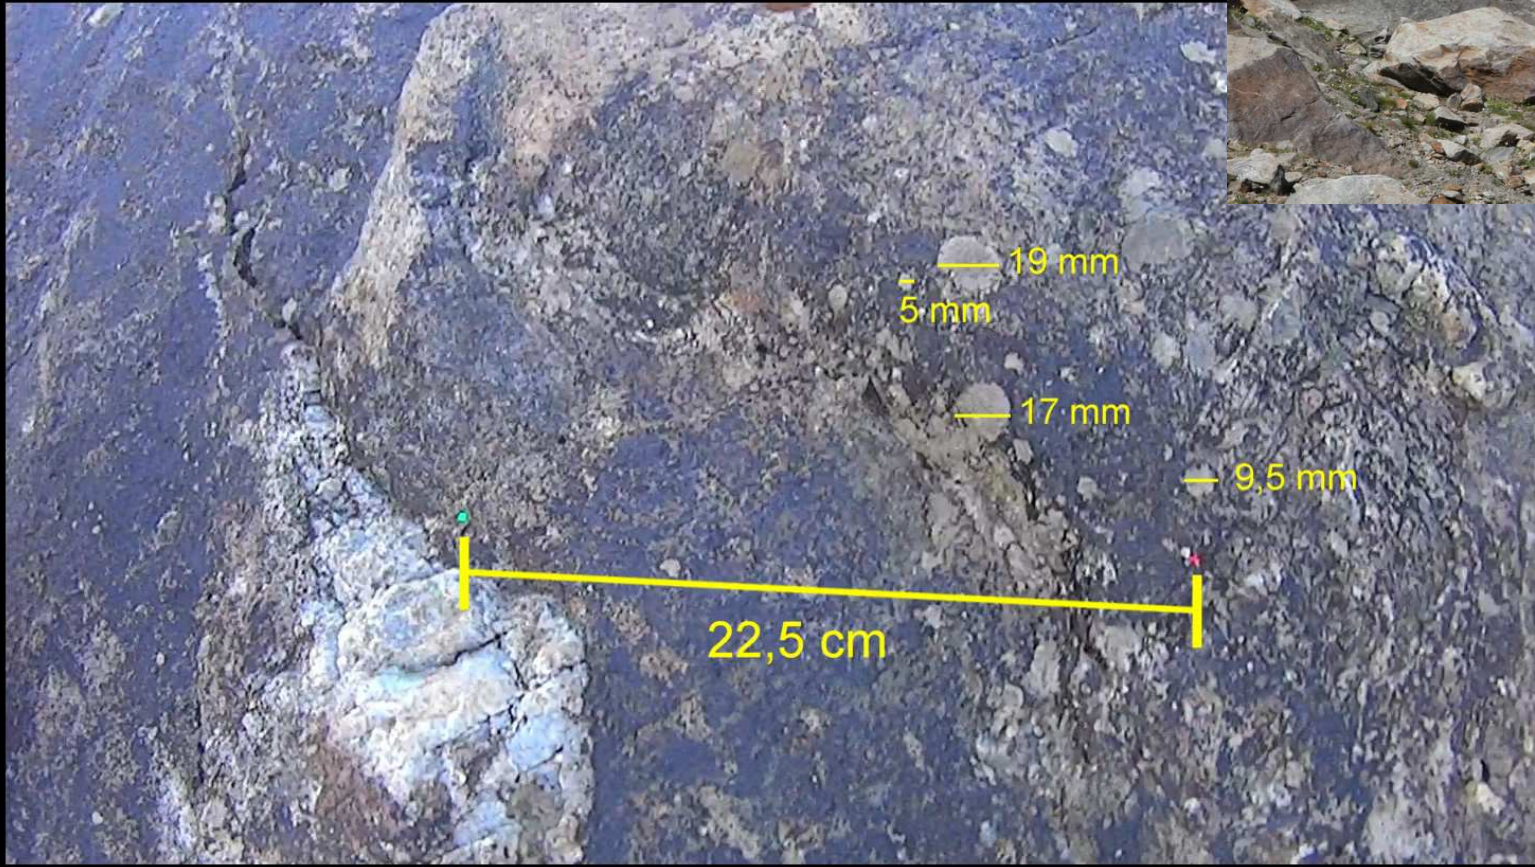
The 2 lasers spot  
separated by 22,5 cm  
give the measurement  
reference

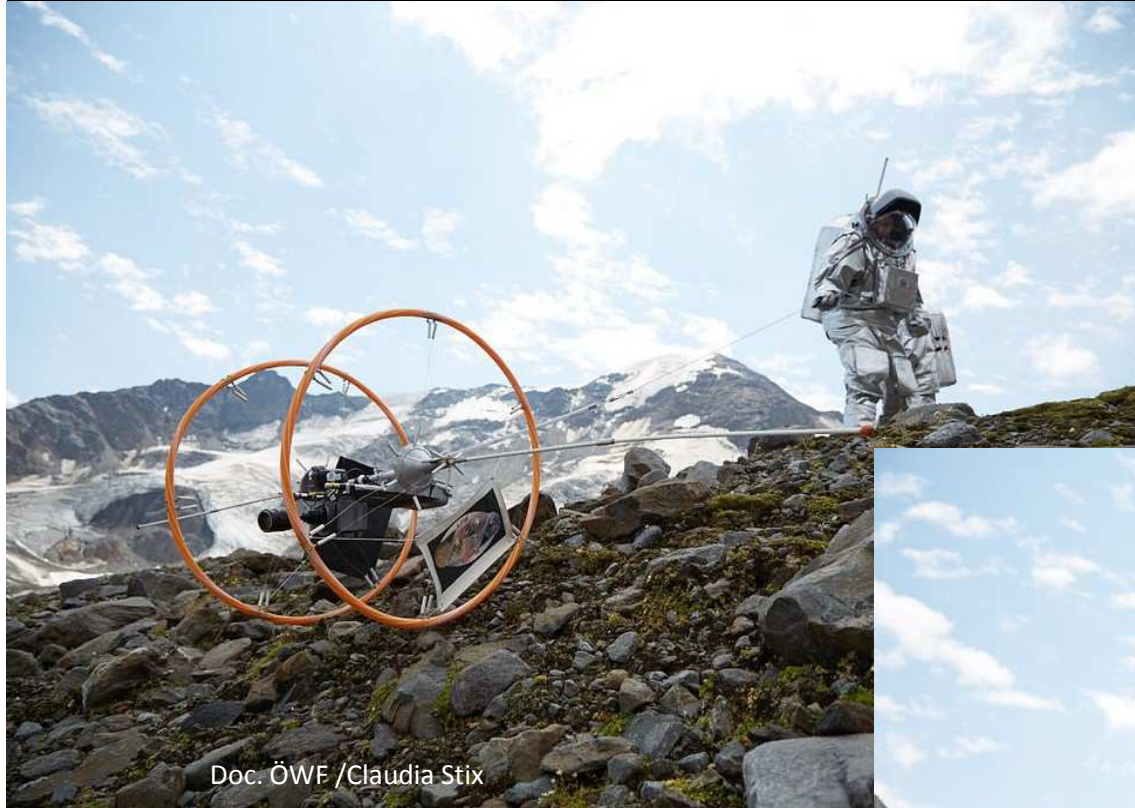
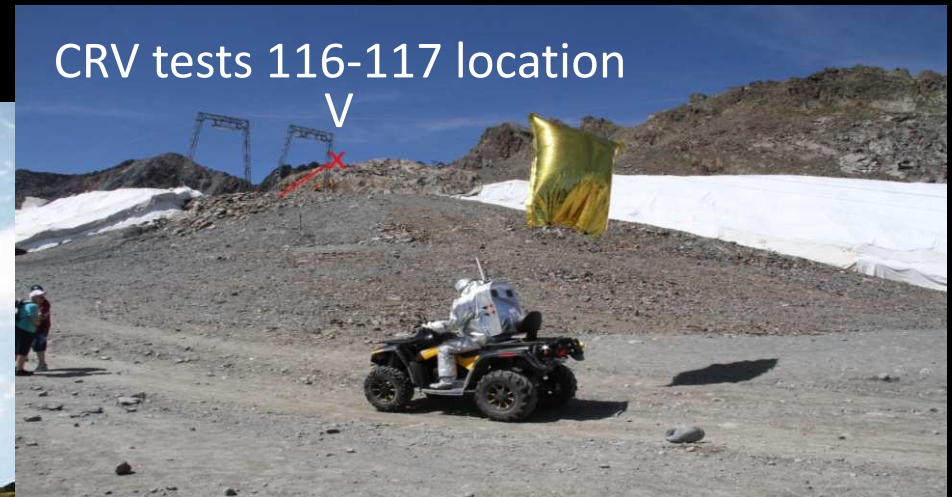
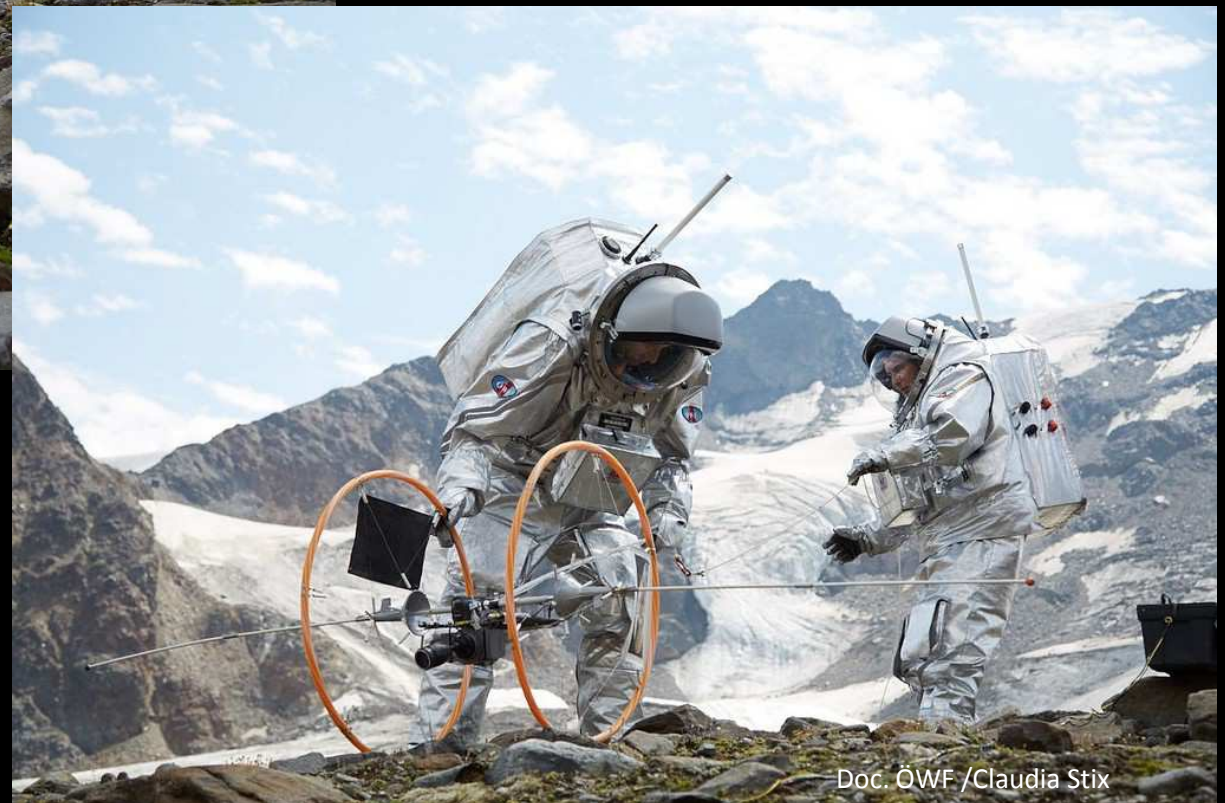
Two tests by analog astronauts in Aouda suits  
No sciencecam video: difficulty in switching on the sciencecam ?
